PROPERTY CONDITION ASSESSMENT REPORT

31840 Paseo Navarra

San Juan Capistrano, CA 92675

Tuesday, May 7, 2019

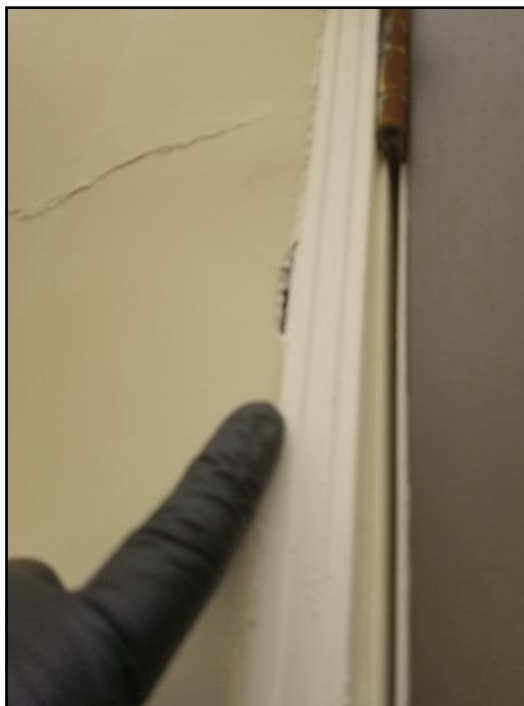
3. Mechanical damage

Holes and open areas within stucco of building. Doorway and/or window crumbling/cracking may lead to water intrusion as well as damage via water rot or mold. Needs immediate attention by licensed contractor.

Location: North Exterior Wall

Task: Repair Further evaluation

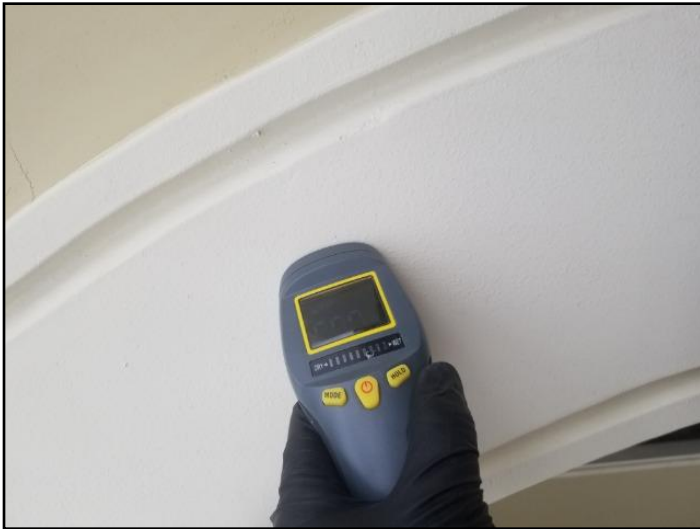
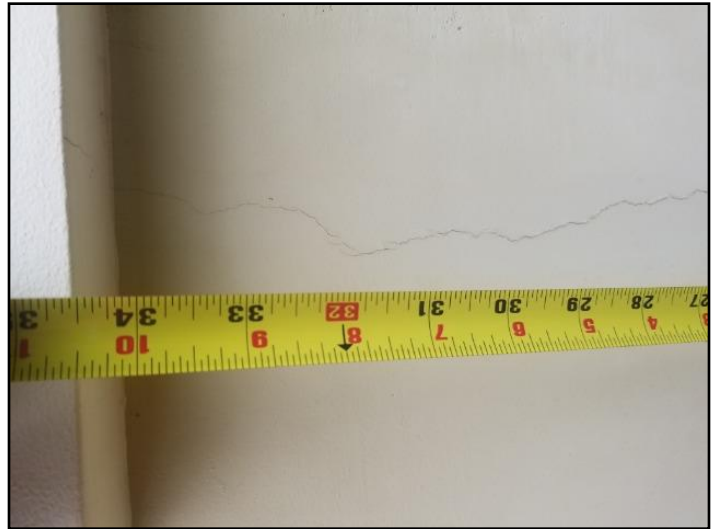
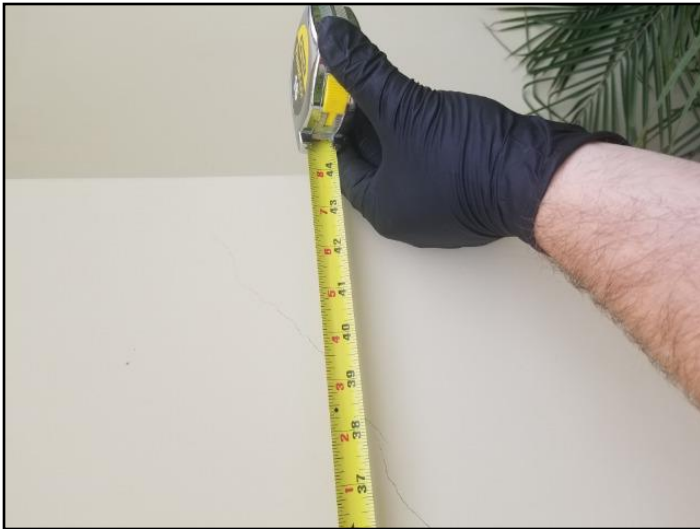
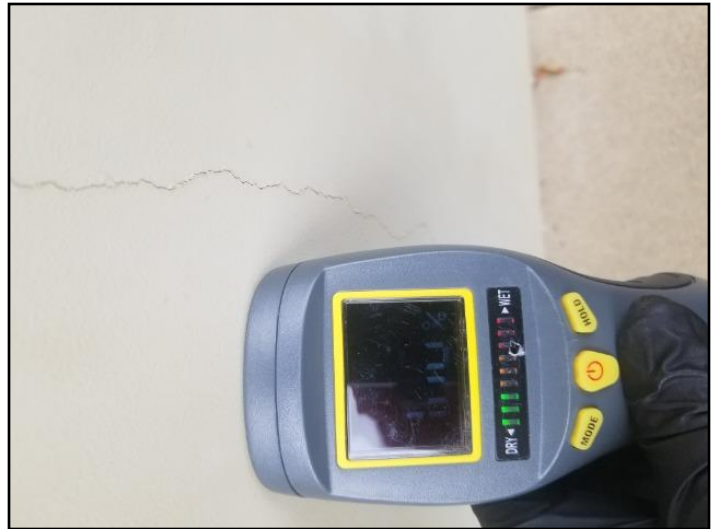
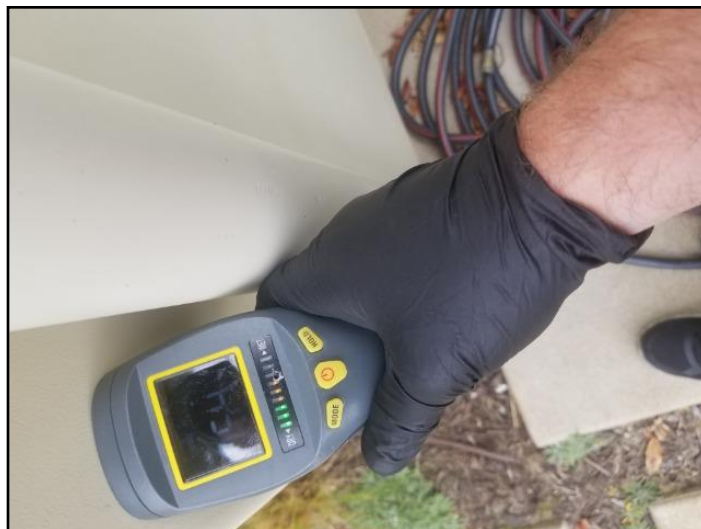
Cracked areas noted on inspection. No water damage noted at time of inspection. Recommend repair by licensed contractor.

Location: Exterior Walls

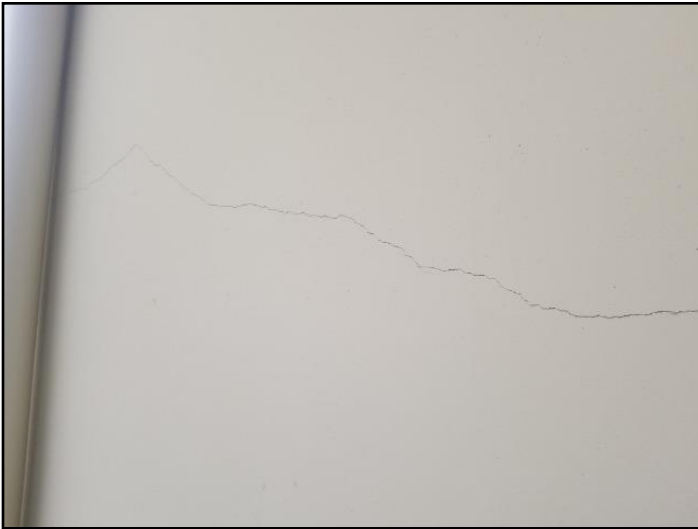
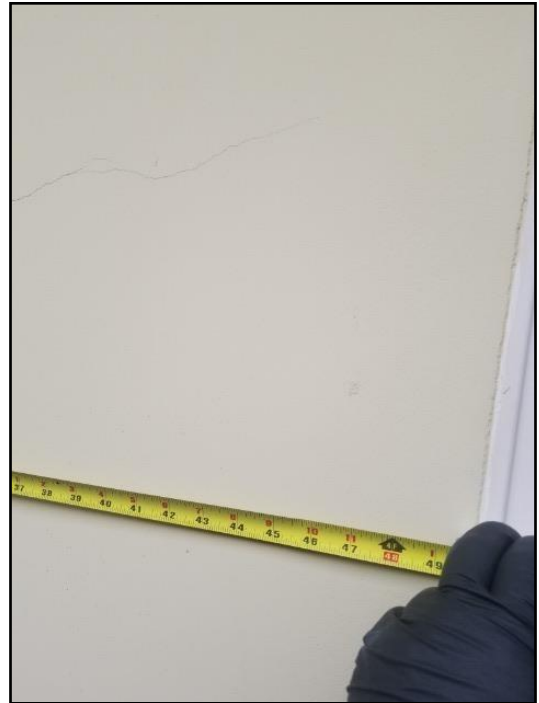
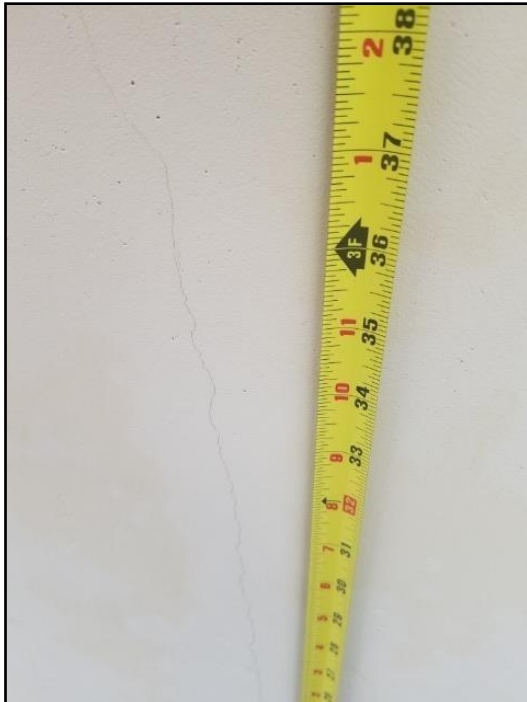
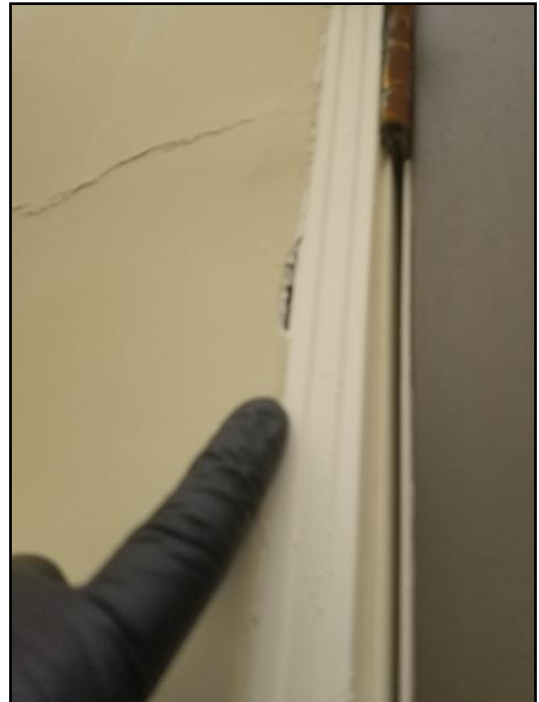
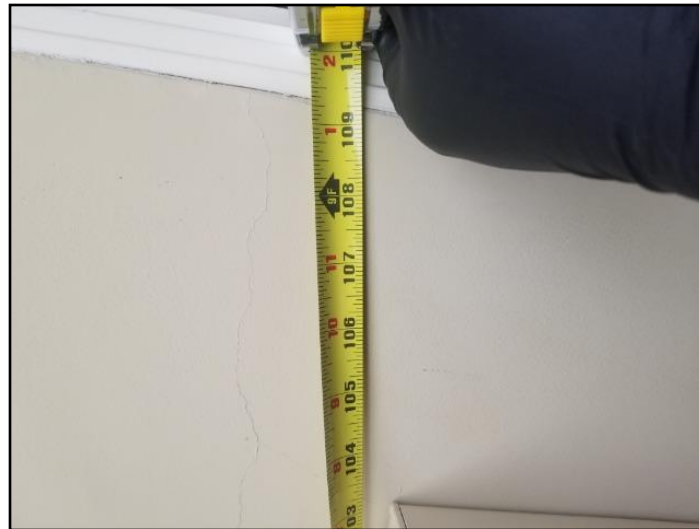
Normal Minor Cracking occurring on Smooth Surface Stucco. There is a few 36" & 48" surface cracks that are cosmetic for now. This is a common result from this particular type of finish. Cosmetic Damage which can be repaired by a professional contractor.

Location: South West Exterior Wall

Task: Repair Service Clean Correct

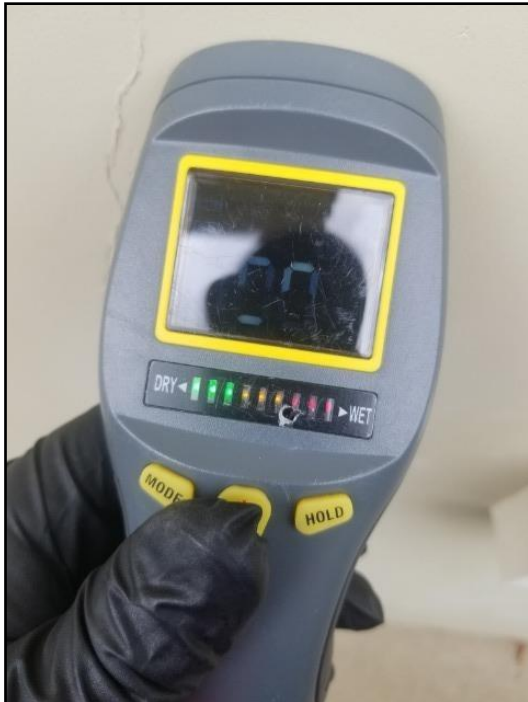
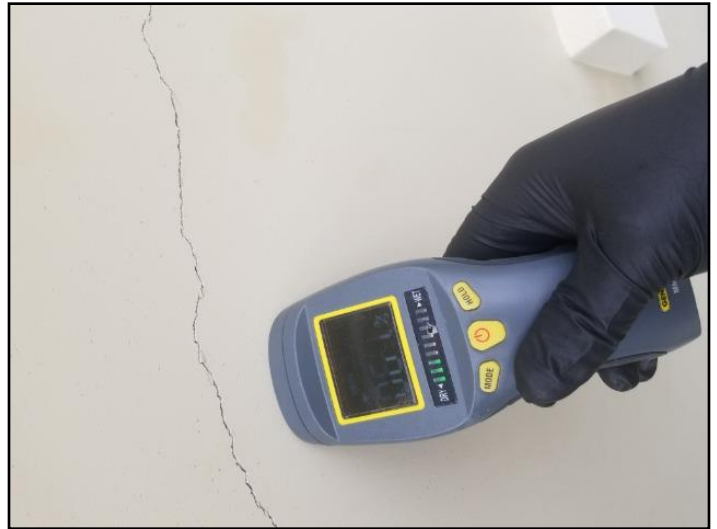
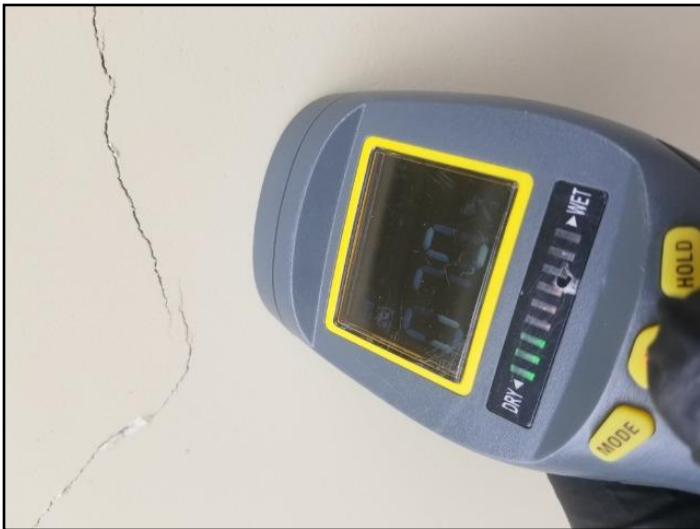
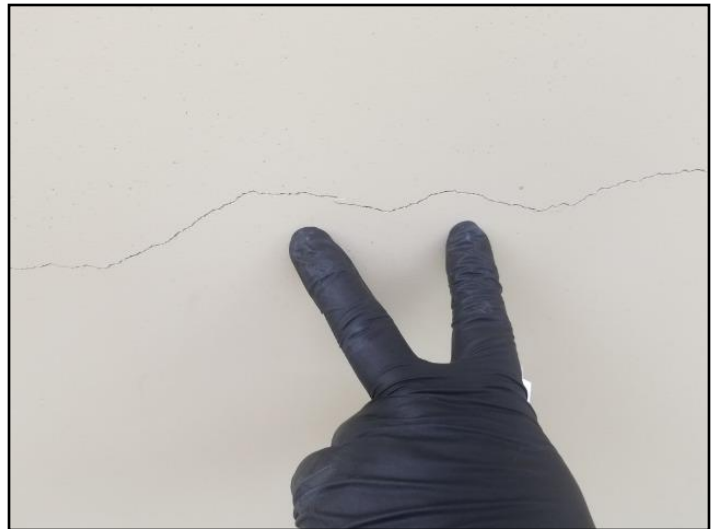
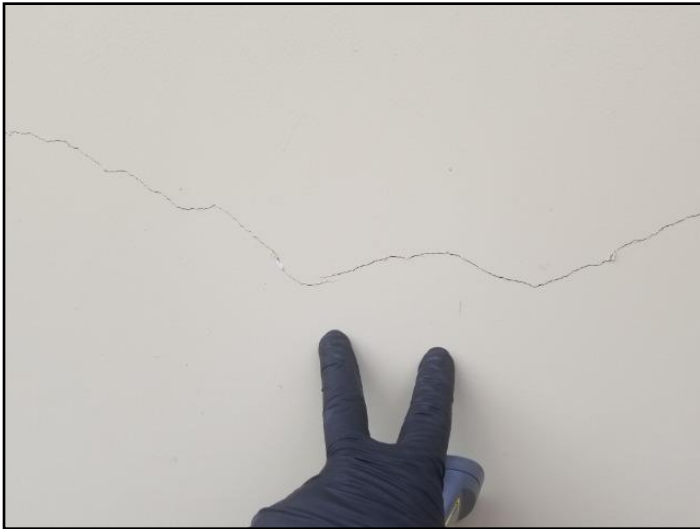
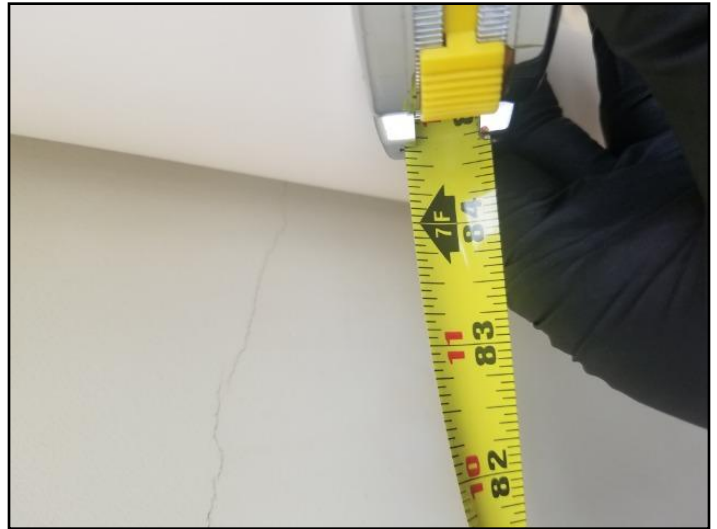
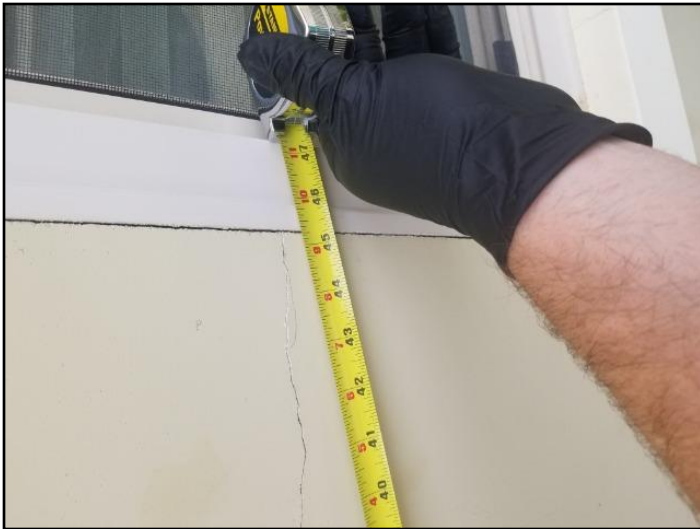
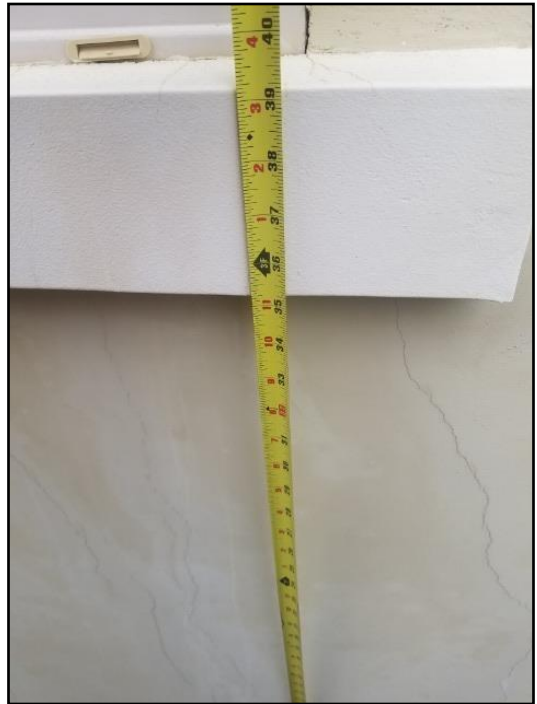
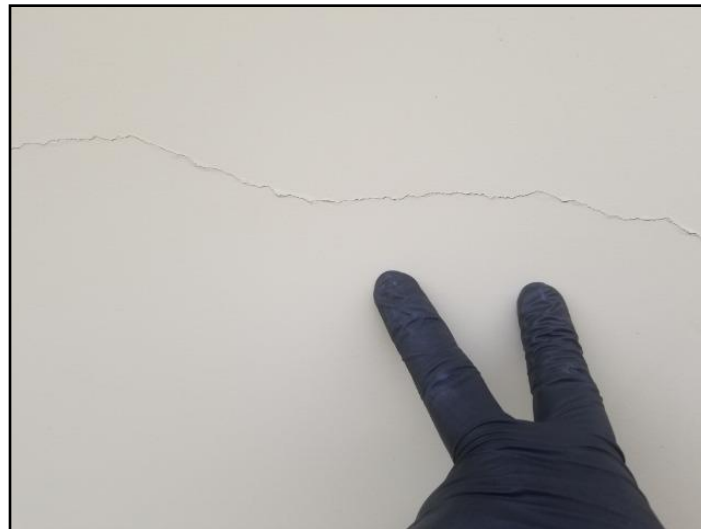
Deeper Cracking noted on exterior stucco walls of home on a few spots. Meter reads high due to recent acrylic painting finish on cracks. Further evaluation by General Contractor recommended.

Location: Throughout Northwest West Exterior Wall

Task: Repair

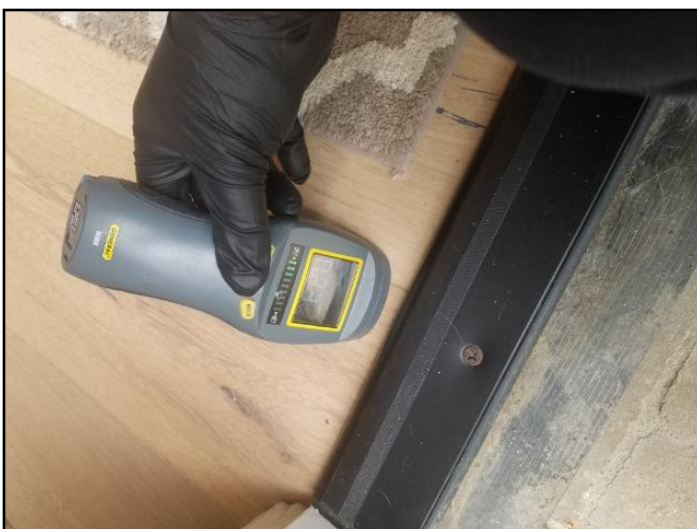
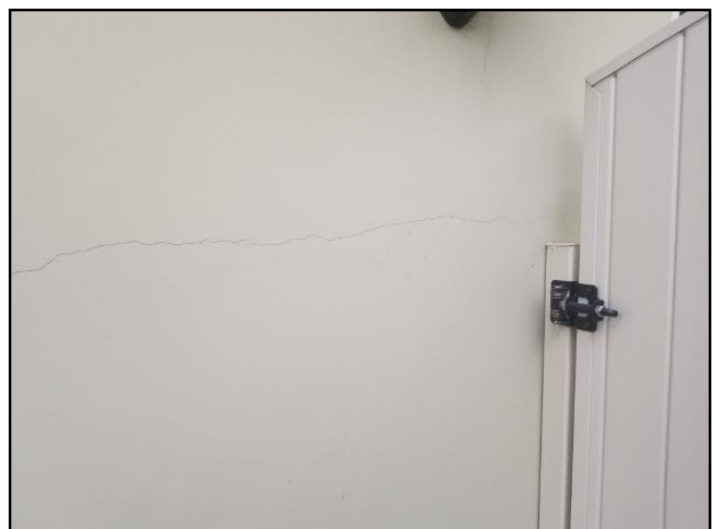
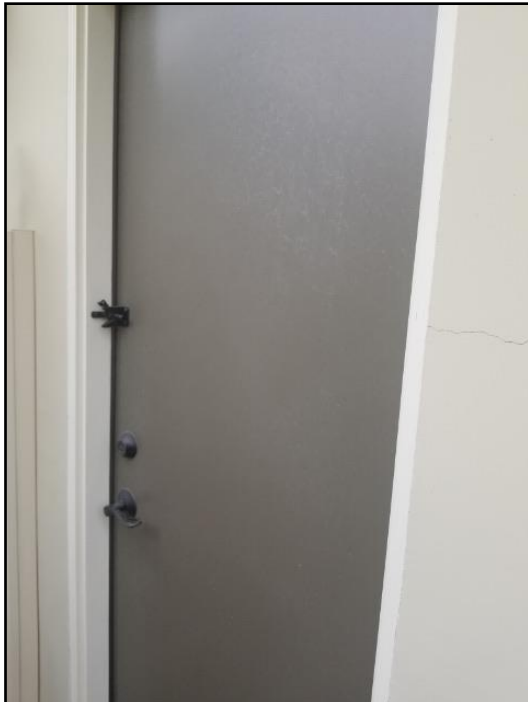
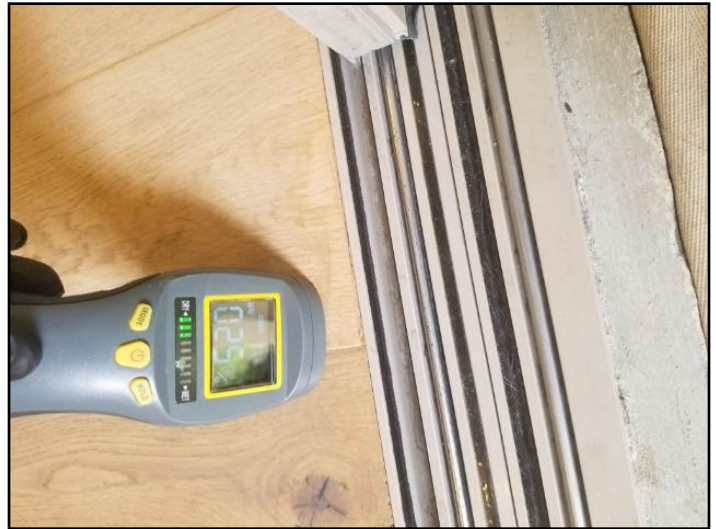
Surface and deeper cracking noted around entry doors from exterior, including side garage entry door and sliding glass doors from rear of home. No Door Damage noted, just cracking around door. Recommend servicing by contractor before damage becomes more severe. No moisture or water damage detected as of now.

Location: North West Exterior Wall

Task: Replace

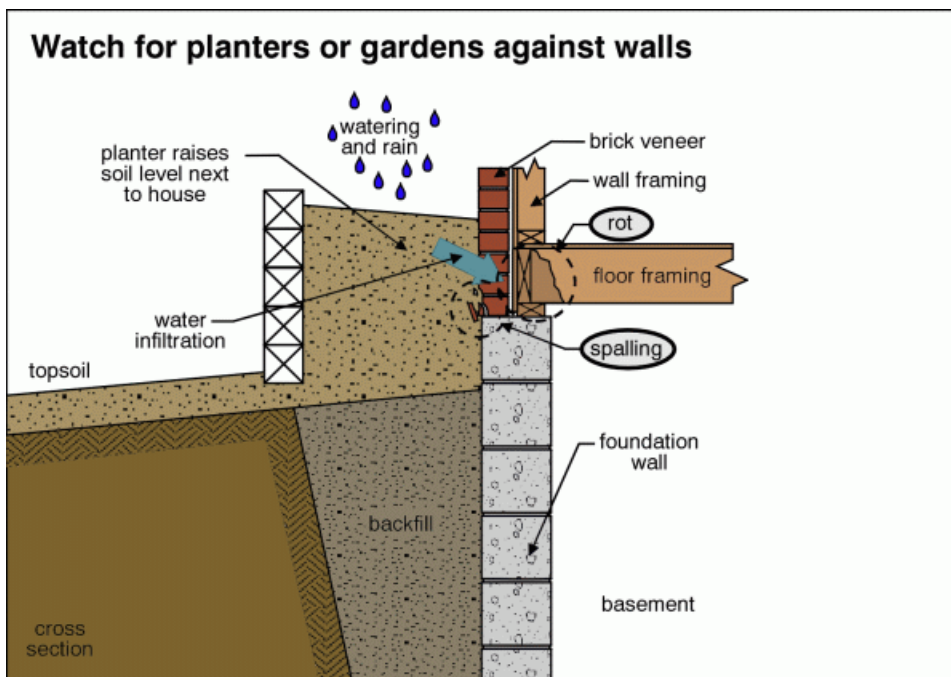
27. Planters and gardens against walls

Landscape must be cut down or replaced further away from building by landscaper. Plants touching house upon entrance can cause water damage and mold.

Task: Service Clean Correct

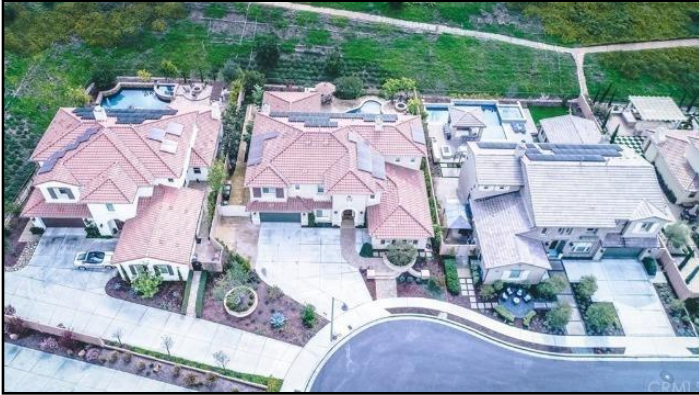
29. Concrete tile

Concrete tile on roof in serviceable condition. Positive slope of home and driveway for proper runoff away from the home. Proper Gutter and drainage system is in place on day of inspection.

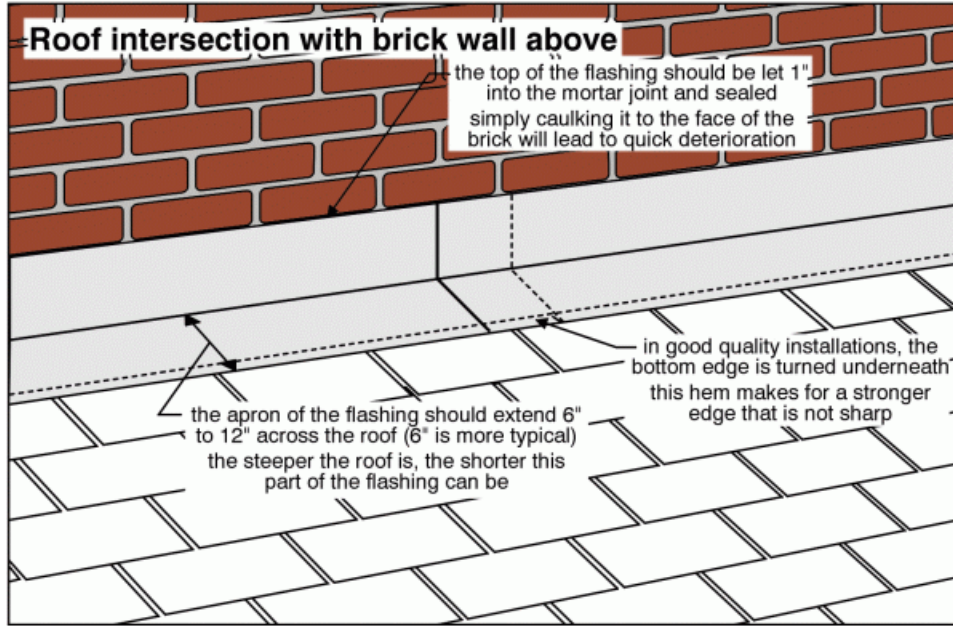
Aluminum flashings noted at time of inspection in serviceable condition. All flashings around roof penetrations are tight, fastened and nailed/glued down. Valley flashings are serviceable with some debris, recommend cleaning.

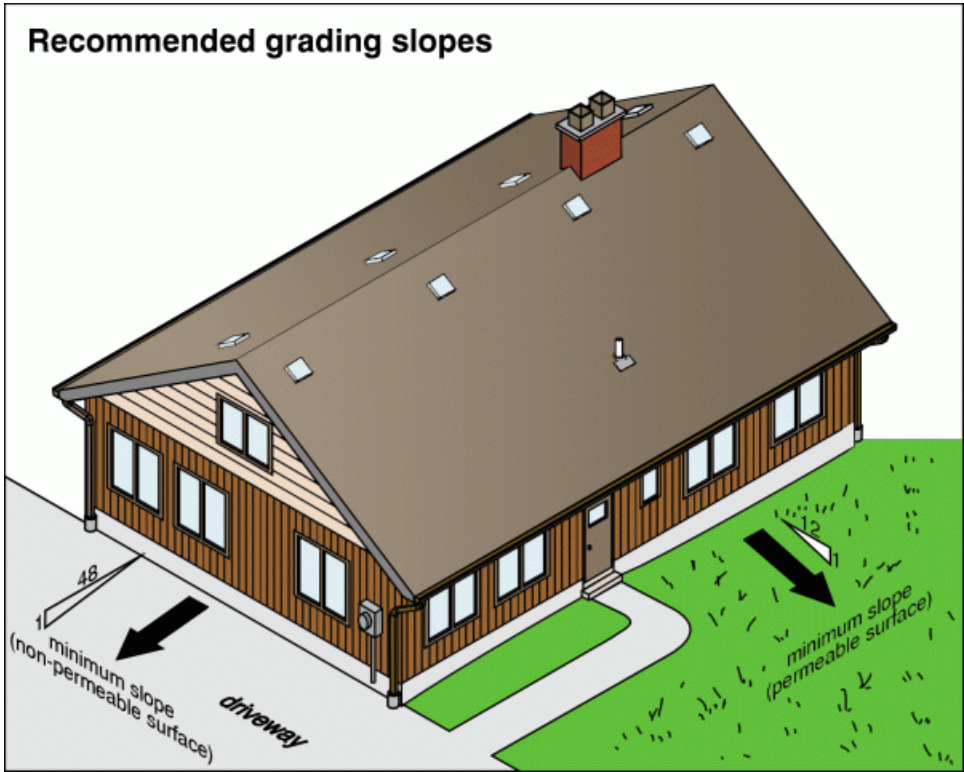
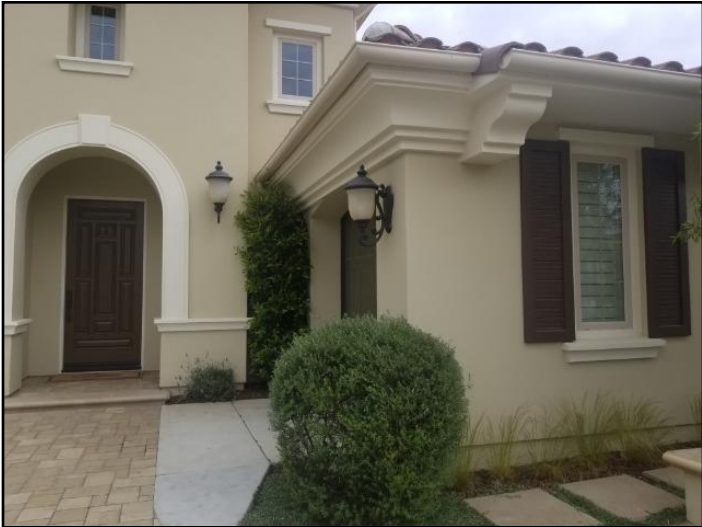
35. Away from building

Positive Pitch with concrete front walkway as is with whole property, including driveway into garages at rear of property.

No severe cracks noted!!!

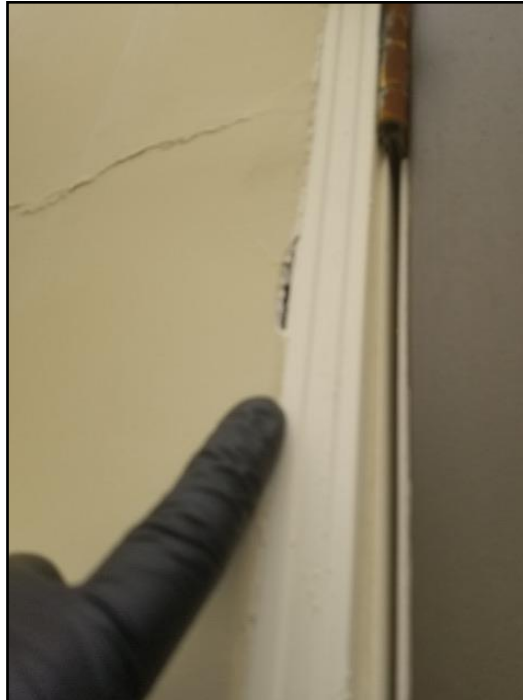
43. Mechanical damage

Holes and open areas within stucco of building. Doorway and/or window crumbling/cracking may lead to water intrusion as well as damage via water rot or mold. Needs immediate attention by licensed contractor.

Location: North Exterior Wall

Task: Repair Further evaluation

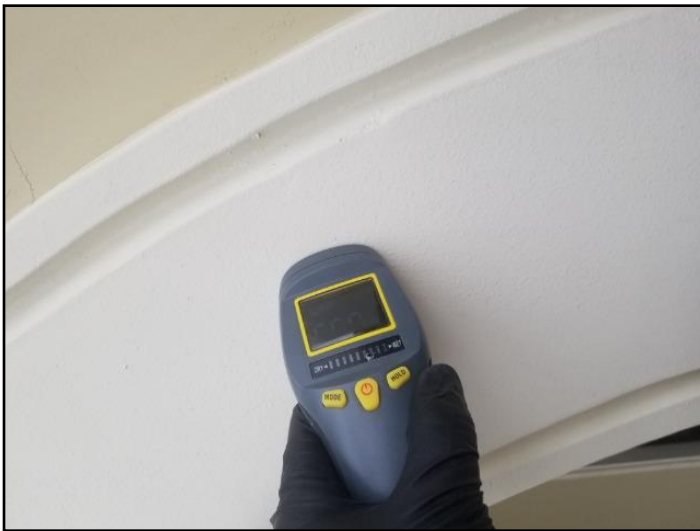
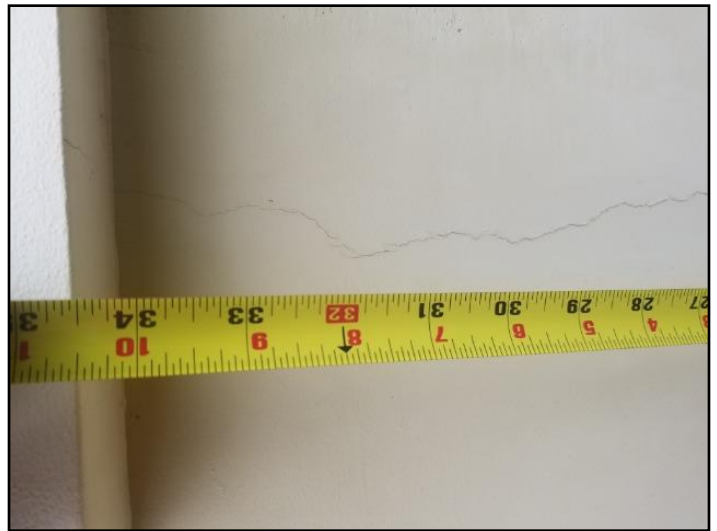
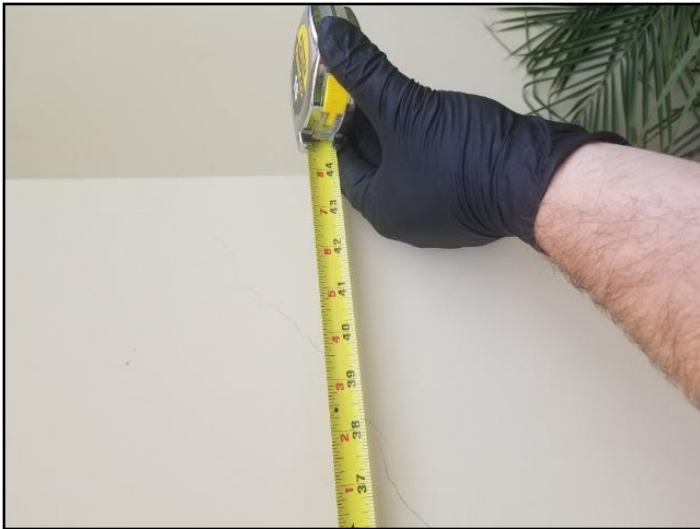
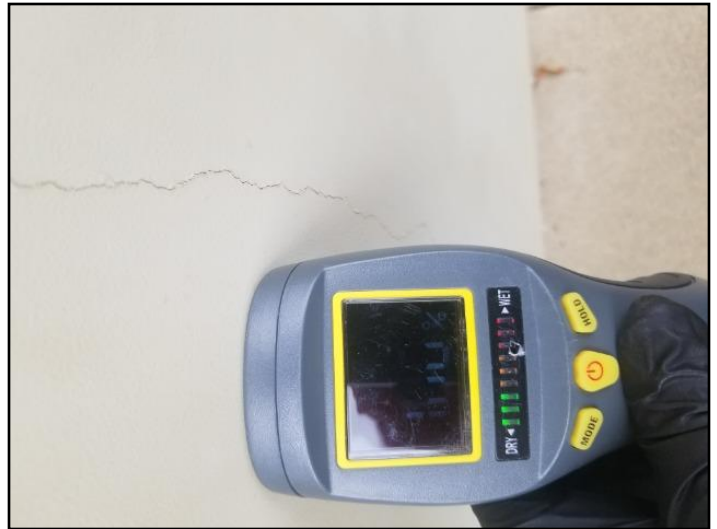
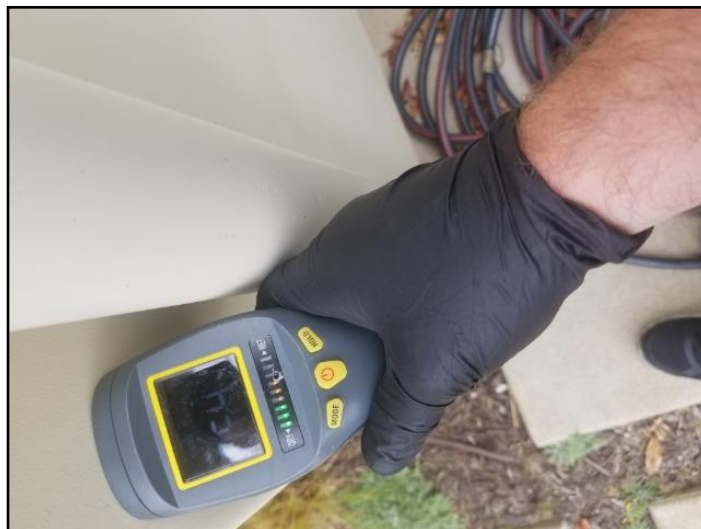
Cracked areas noted on inspection. No water damage noted at time of inspection. Recommend repair by licensed contractor.

Location: Exterior Walls

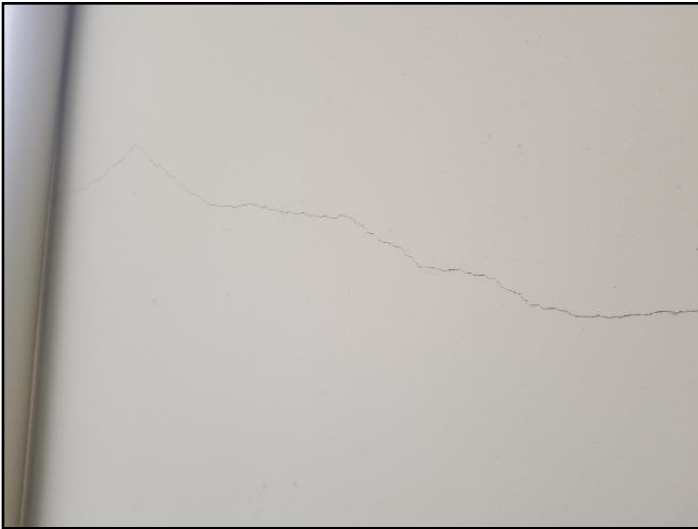
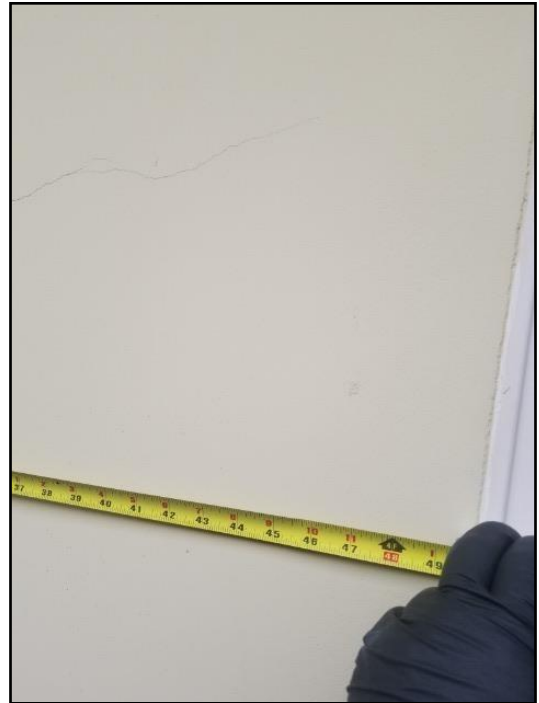
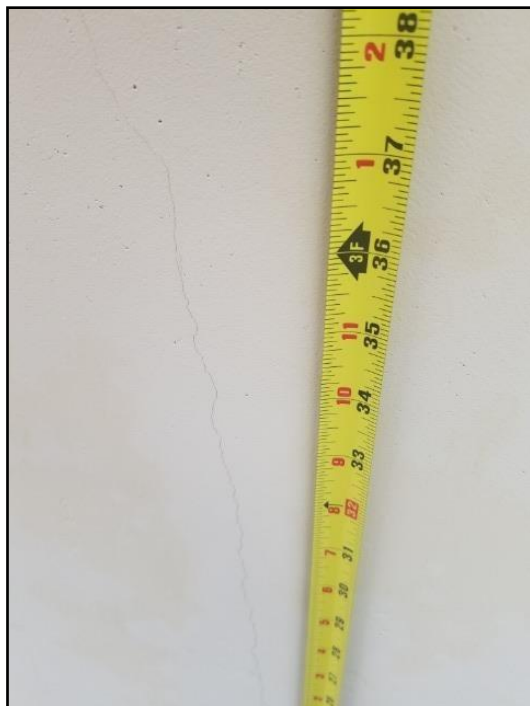
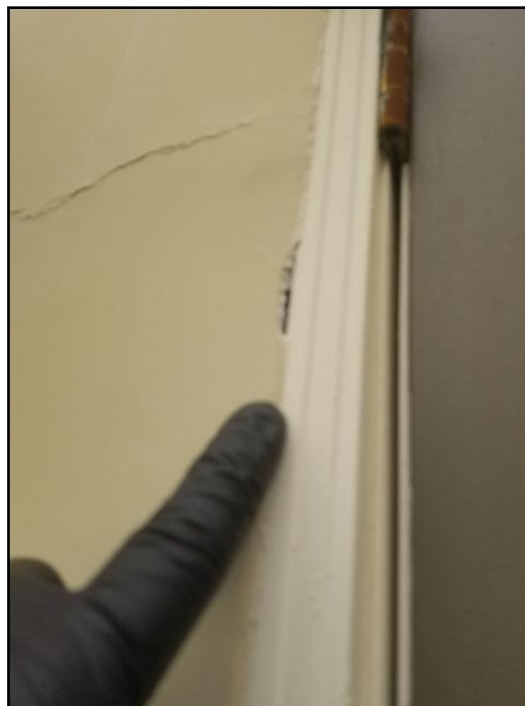
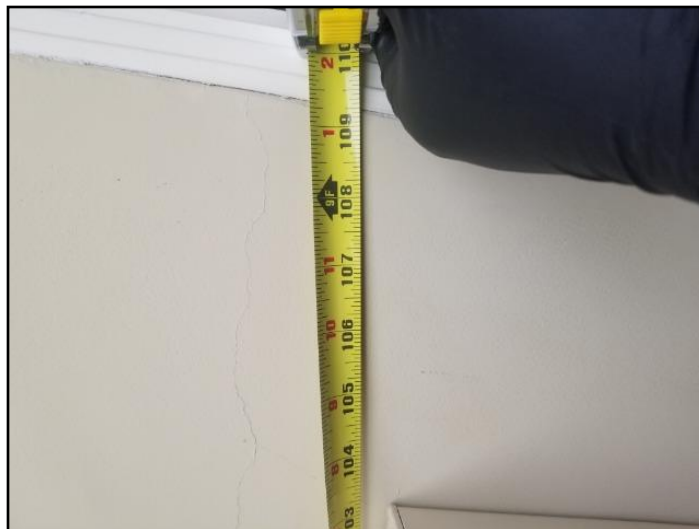
Normal Minor Cracking occurring on Smooth Surface Stucco. There is a few 36" & 48" surface cracks that are cosmetic for now. This is a common result from this particular type of finish. Cosmetic Damage which can be repaired by a professional contractor.

Location: South West Exterior Wall

Task: Repair Service Clean Correct

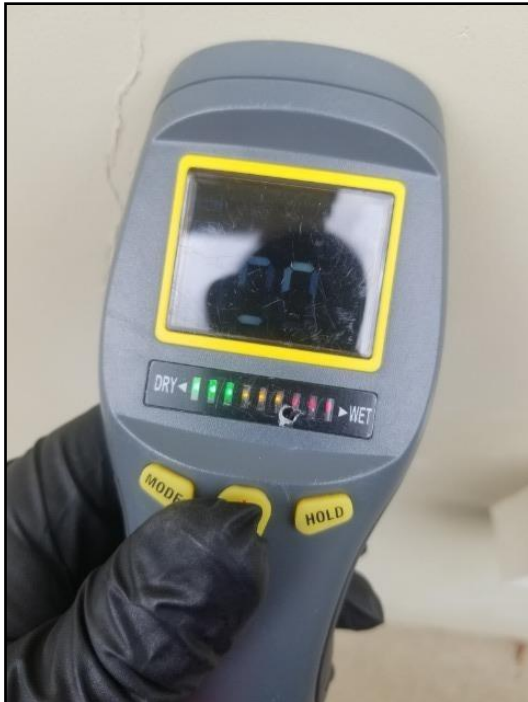
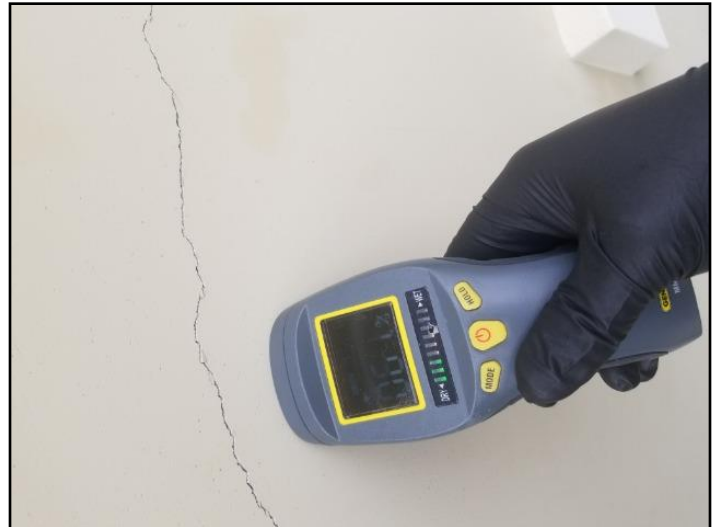
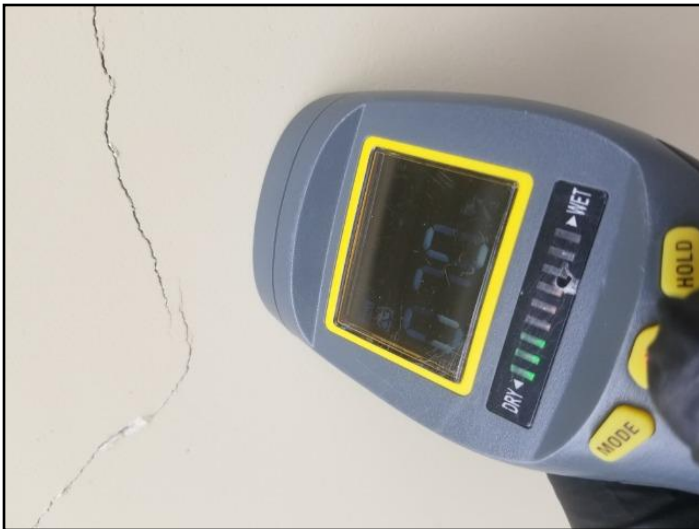
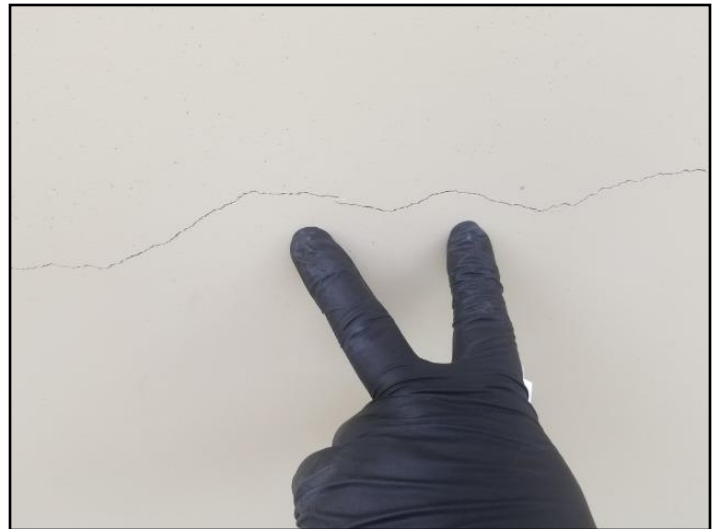
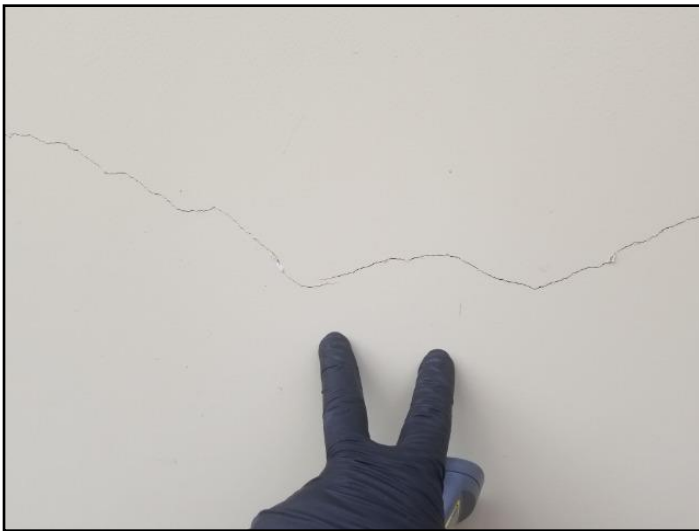
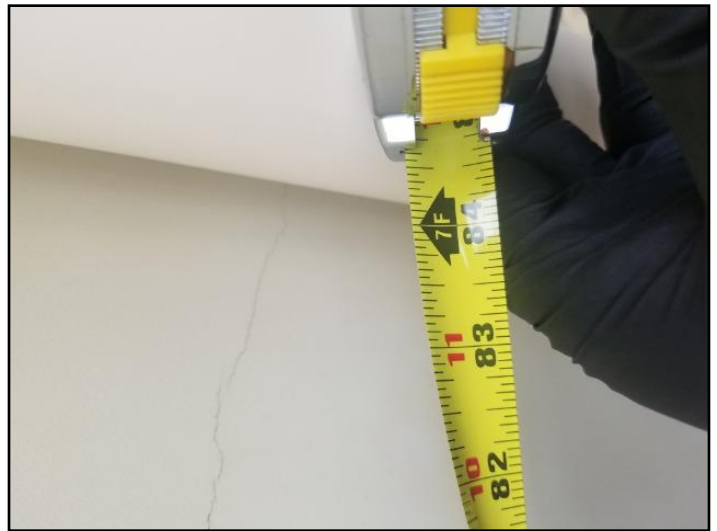
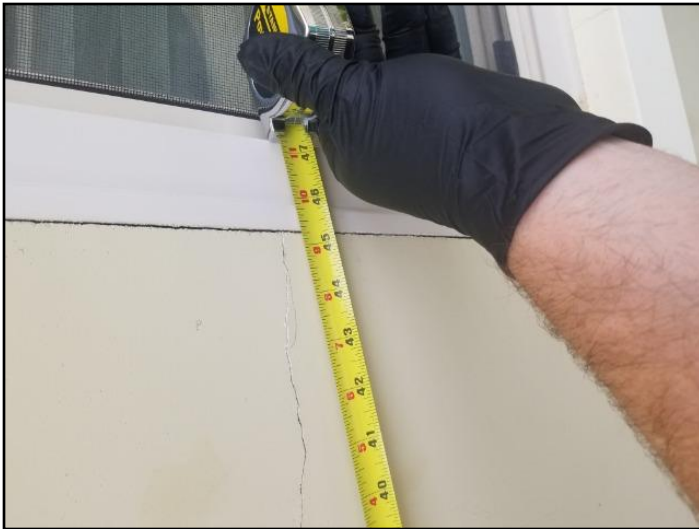
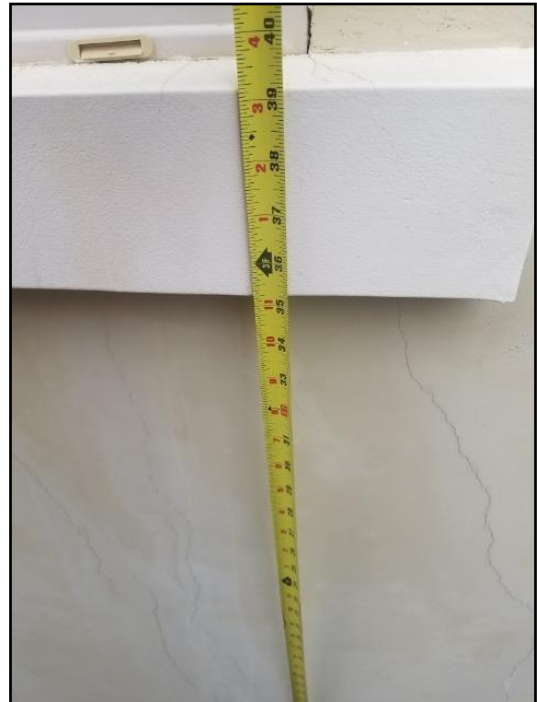
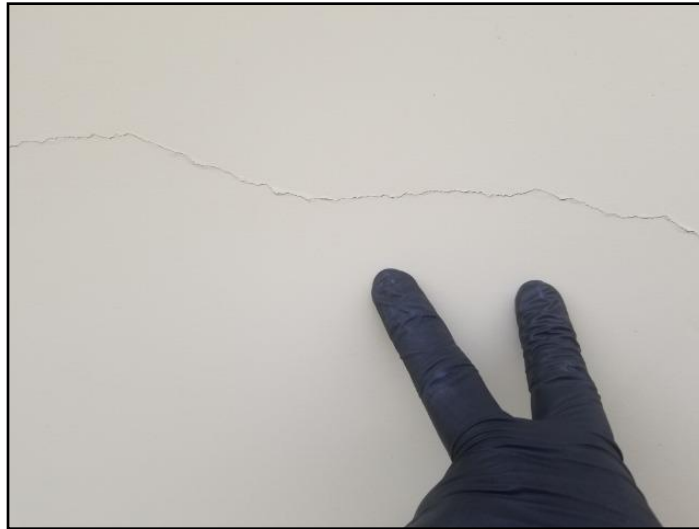
Deeper Cracking noted on exterior stucco walls of home on a few spots. Meter reads high due to recent acrylic painting finish on cracks. Further evaluation by General Contractor recommended.

Location: Throughout Northwest West Exterior Wall

Task: Repair

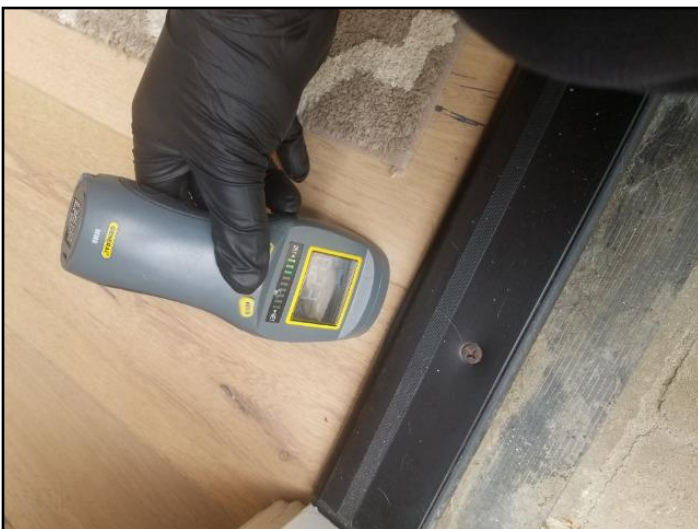
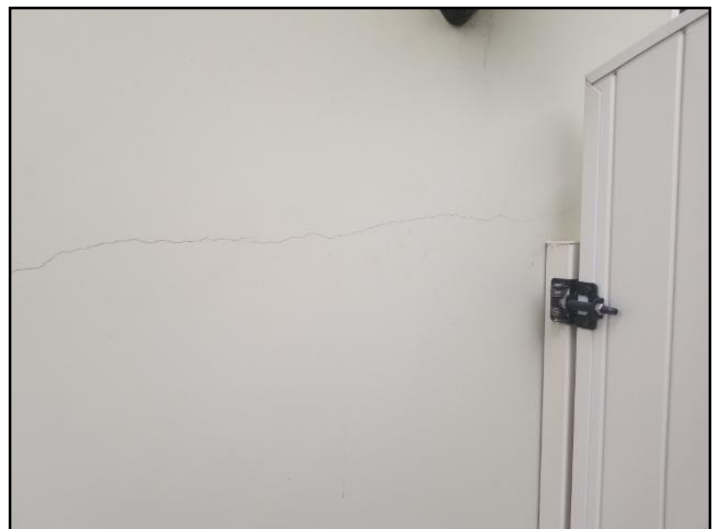
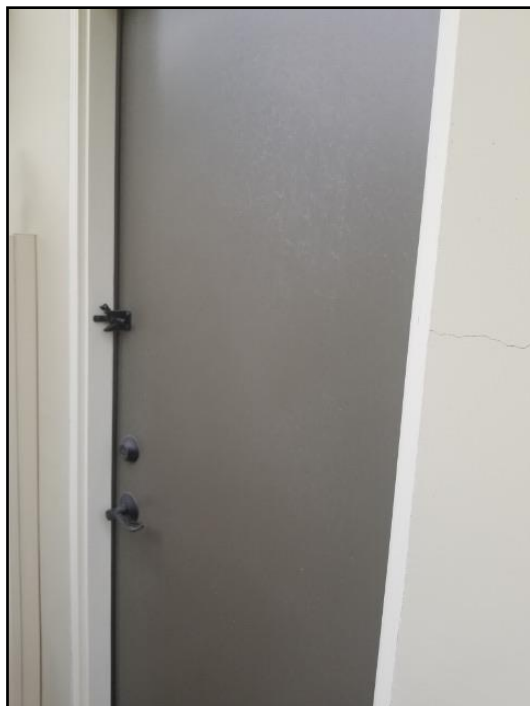
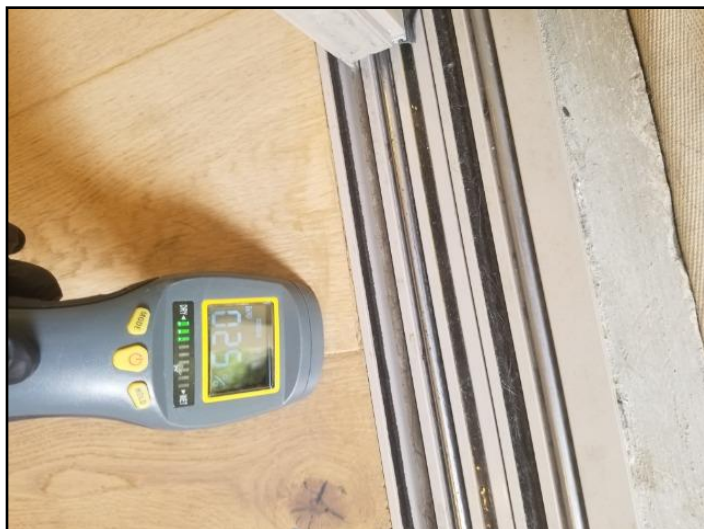
Surface and deeper cracking noted around entry doors from exterior, including side garage entry door and sliding glass doors from rear of home. No Door Damage noted, just cracking around door. Recommend servicing by contractor before damage becomes more severe. No moisture or water damage detected as of now.

Location: North West Exterior Wall

Task: Replace

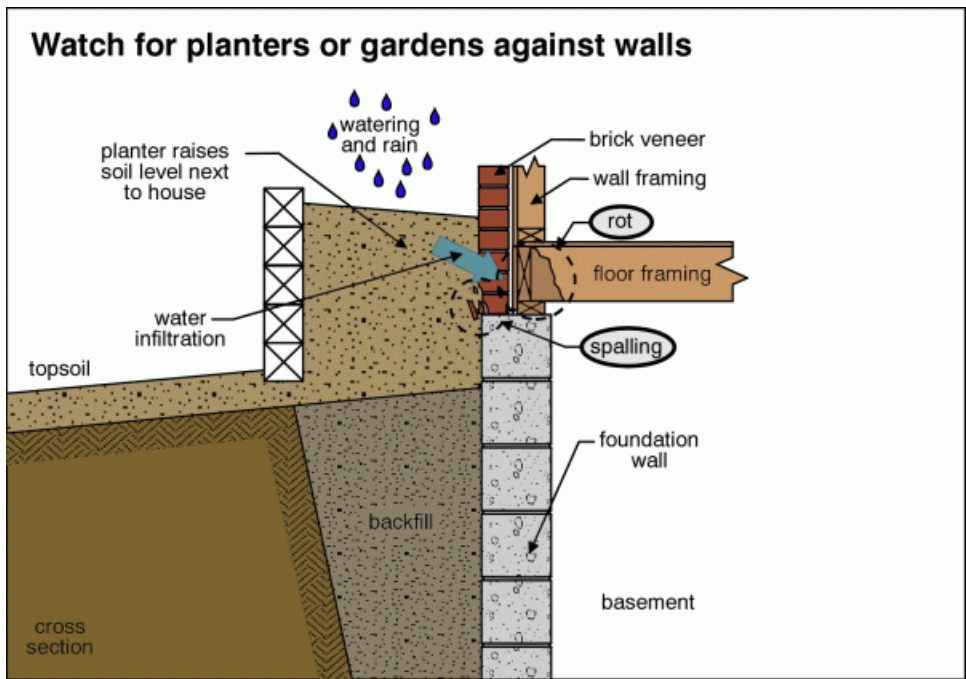
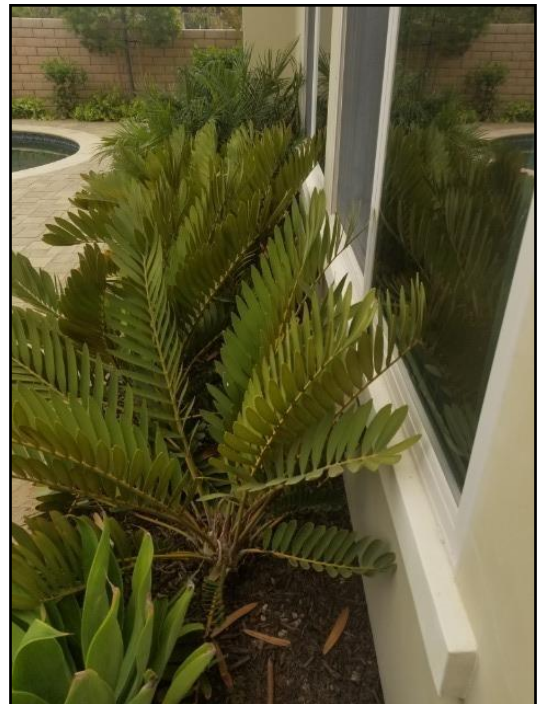
Landscape must be cut down or replaced further away from building by landscaper. Plants touching house upon entrance can cause water damage and mold.

Task: Service Clean Correct
