PROPERTY CONDITION ASSESSMENT REPORT

31840 Paseo Navarra

San Juan Capistrano, CA 92675

Tuesday, May 7, 2019

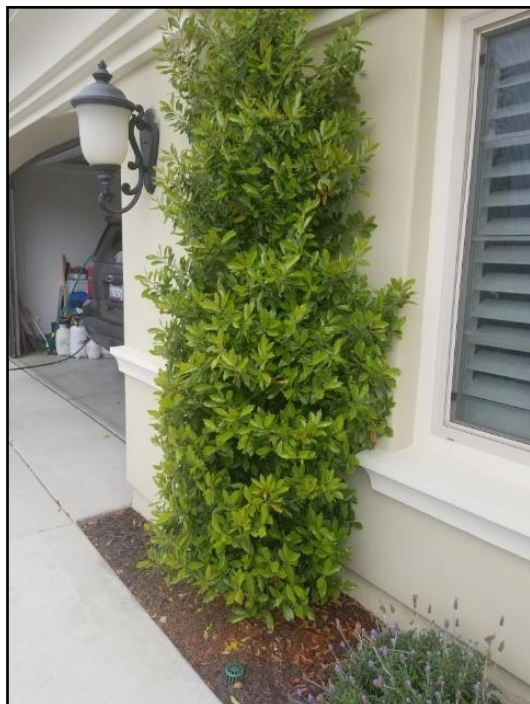
27. Planters and gardens against walls

Landscape must be cut down or replaced further away from building by landscaper. Plants touching house upon entrance can cause water damage and mold.

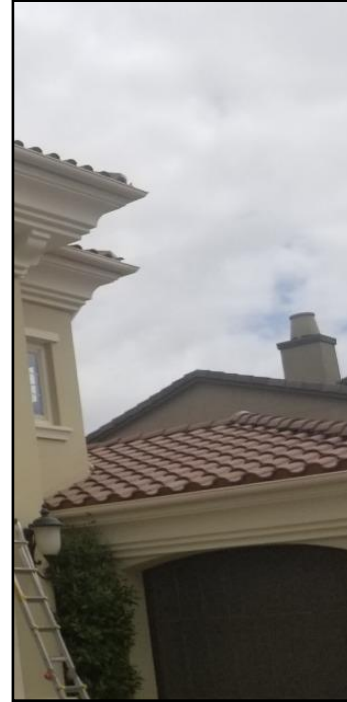
30. Concrete tile

Concrete tile on roof in serviceable condition. Positive slope of home and driveway for proper runoff away from the home. Proper Gutter and drainage system is in place on day of inspection.

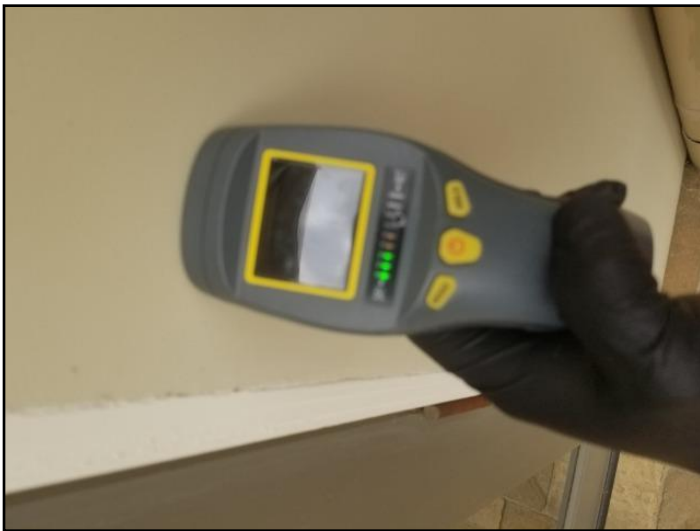
36. Stucco

The Exterior walls and House Trim consist of Stucco. The West Side of the house had freshly painted cracks as well as some of the gutter system as pointed out.

There is no severe cracking noted throughout the exterior smooth stucco on the east and North or east sides of the home. Moisture readings are all clear and under the potential danger zone areas for water. Please see recommendations.
